# CLEARLINE PROFILER CASE STUDY

## CIPP RELINING FAILURE

**Location:** Portland, Oregon, USA

**Customer:** City of Portland

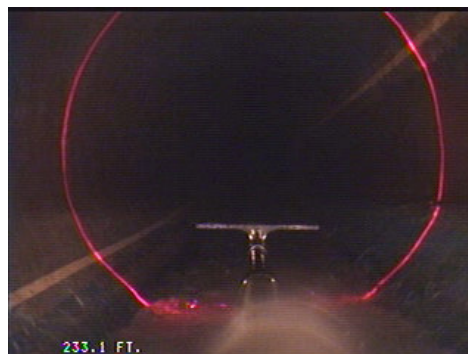
With the CCTV camera configured for a 24" pipe, the top portion of the laser profile was missing for the 30" section of pipe (see figure 1). The profile that was in view, allowed measurement of features such as lifts and ridges that were found during the 30" pipe inspection. In fact, the presence of the laser profile made it easier to see where the lifts and ridges were.

*Figure 1: An example of the laser profile within the 30" section of re-lined pipe*

During the forward inspection of the 30" pipe, we observed many ridges in the liner. We were able to measure, with ease, these ridges in the liner. In several areas the ridges were as high as 2" (50mm). In many cases, because of the position and angle of the ridges, no estimate of the height of the ridge could be made without the use of the laser profiler.

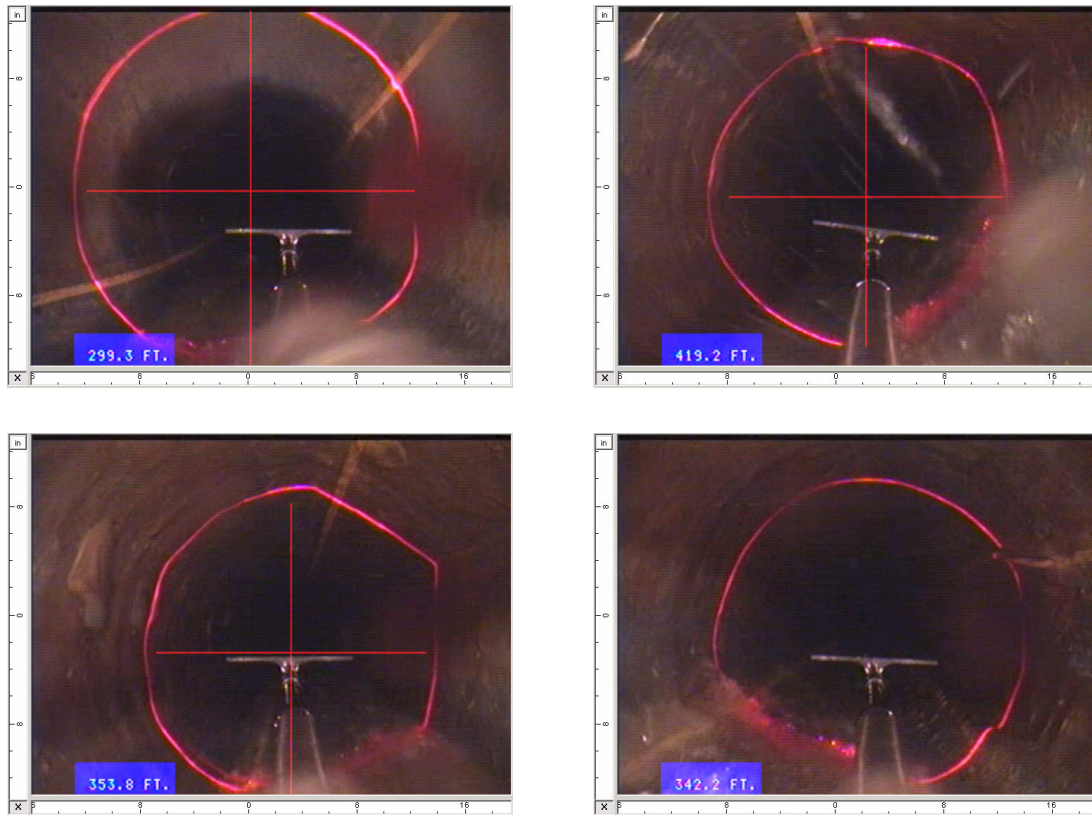
*Figure 2: Examples of the laser profile at 299.3ft, 342.2ft, 353.8ft and 419.2ft*

At 300ft the pipe size reduced from 30" to 24", figure 2. Serious deformation of the liner started at 340ft. By 350ft the started to ride up the side of the pipe. At 419.2ft the forward inspection was terminated as the CCTV camera was very close to tipping over.

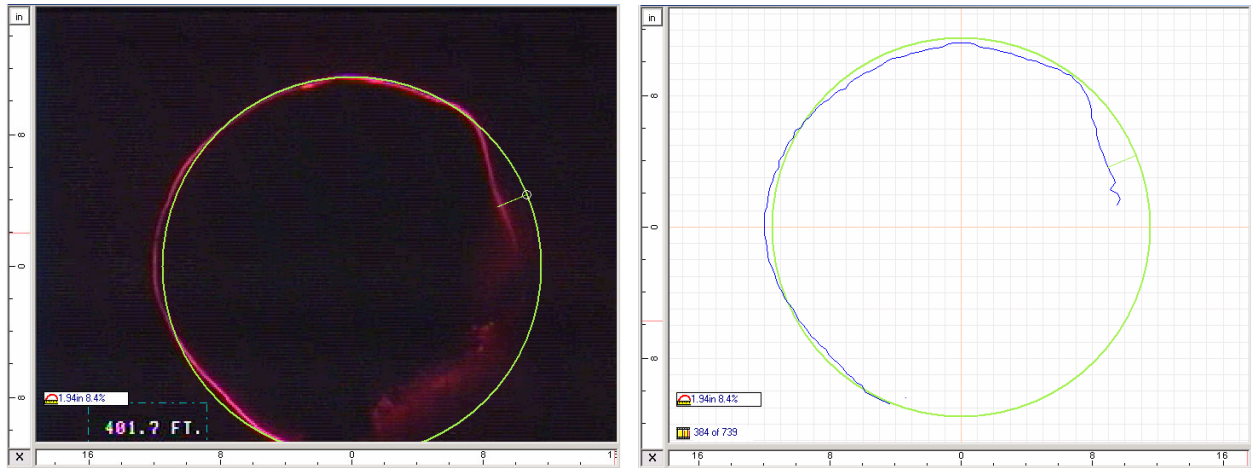
Back in the office the video was analyzed with the ClearLine software. The machine vision function of the software was able to obtain a near perfect profile for the section of pipe inspected. In figure 3, note that there is no profile for the water level part of the pipe profile. The turbulent water had to be removed from the digital profile so that it would not affect the pipe center and Delta calculations.

Figure 3 shows an example of one location where maximum liner lift was found.

Figure 3: At 401.7ft, lift in liner measured 1.94" (8.4%) for both the manual and digital methods

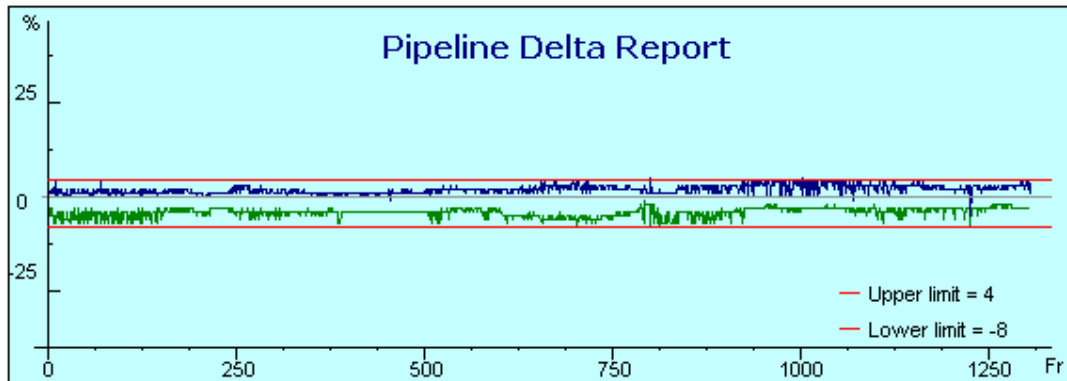
The green circle in the images shown in figure 4 is the expected internal diameter of the lined pipe, in this case 23" (584mm). Accurate manual measurements were done where specific points in the profile required measurement. The software's built-in functions currently only cover cross-sectional area, ovality and the maximum radius and minimum radius for each pipe profile.

The Delta report is a graph of the maximum and minimum radius for each pipe profile. This report was used to determine the extent of the liner lift along the 24" section of pipeline.

Figure 4: Delta report for a section of the 24" pipe, from 419.2ft to 373.0ft

Along the length of the 24" section of pipe surveyed, the maximum lift measured was 1.9" (48mm) or 8.4%.

The ClearLine Profiler was able to determine the amount of deformation of the liner along the 24" pipeline. Therefore removing any doubt as to how much of the liner needed to be removed. Also encouraging in this project was the clarity of the profile for the 30" section of the pipeline. With the appropriate CCTV camera setup the 30" re-lined pipe section could also have been profiled.
