Clearline Profiler Inspection Report

Date: 24th February 2006

Customer: ProPipe and Brown & Caldwell

Pipe Size: 33in

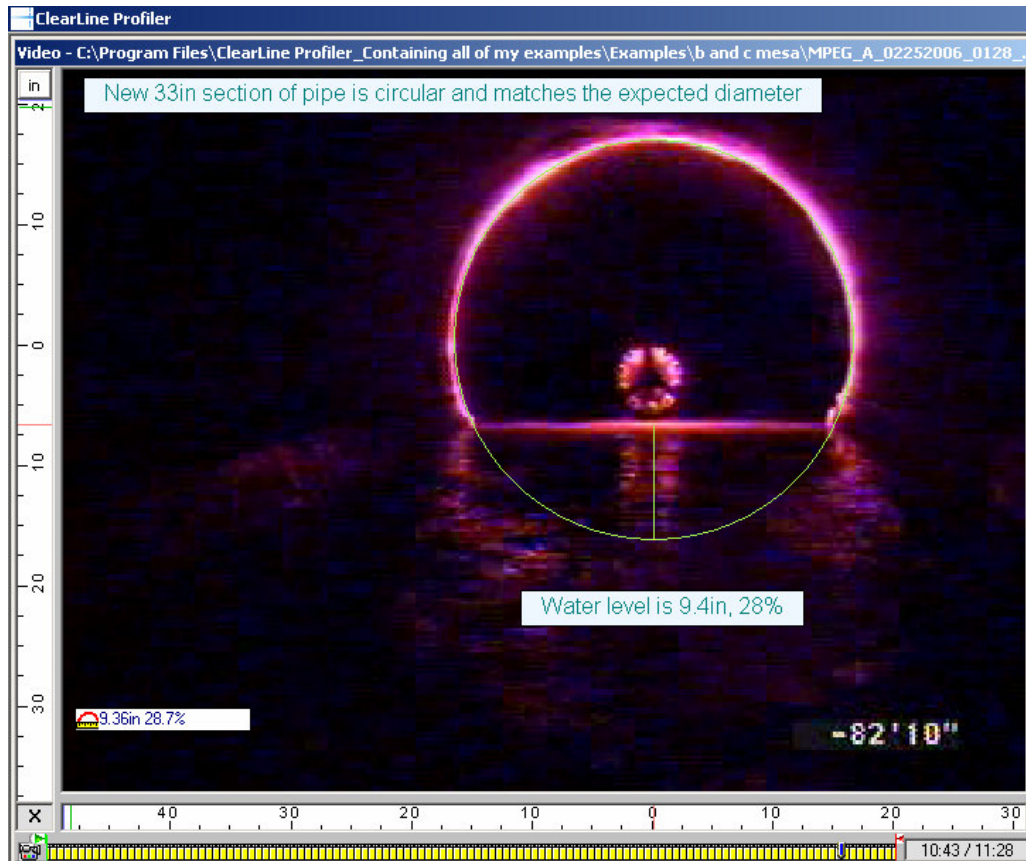
Figure 2: The profiler setup verified and the water level is about 28% for the line.

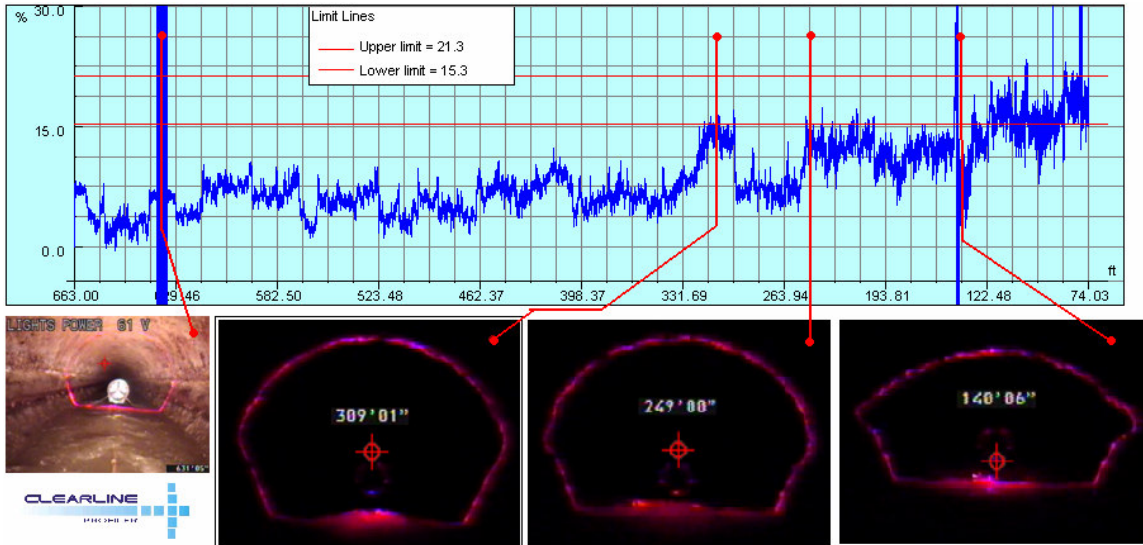
As expected the standard CCTV inspection detected where the pipeline had partially collapsed and that there was severe erosion along its length. It was not clear how much. During the lights off laser profiler inspection it became very clear that the pipeline had deformed into very unusual shapes along its length. Further clarification was obtained after post processing the laser video inspection.

As is typical for H₂S erosion, the Capacity graph was used to highlight any changes in profile cross-sectional area.

Figure 3: The ClearLine Profiler Capacity report with selected video profiles

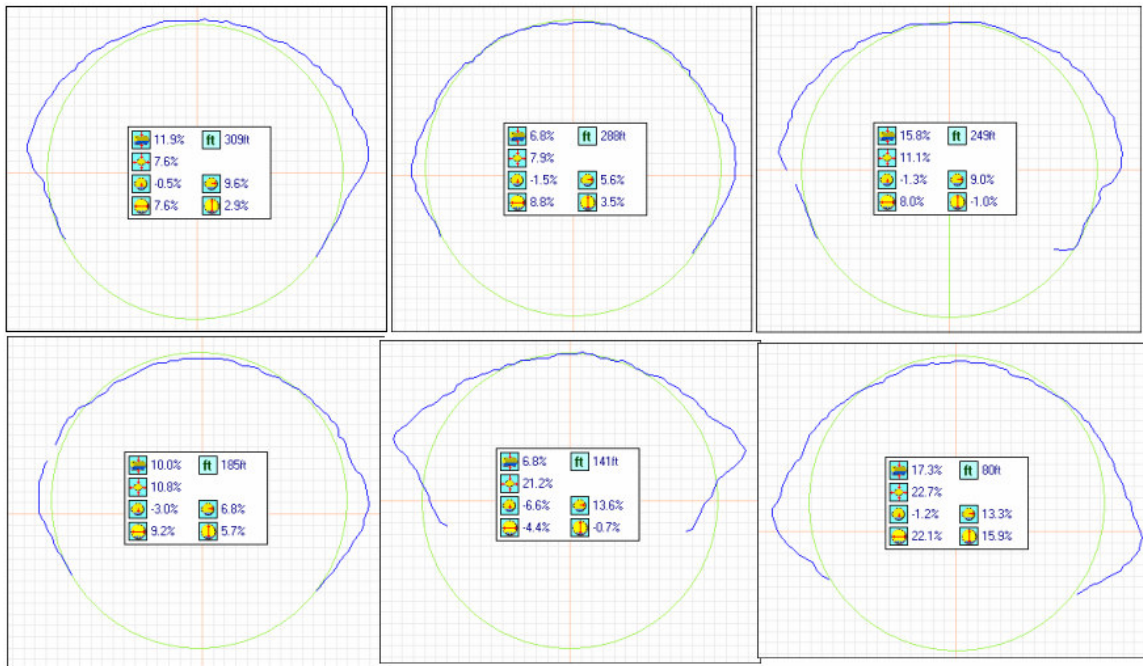
Figure 4: The digital profiles

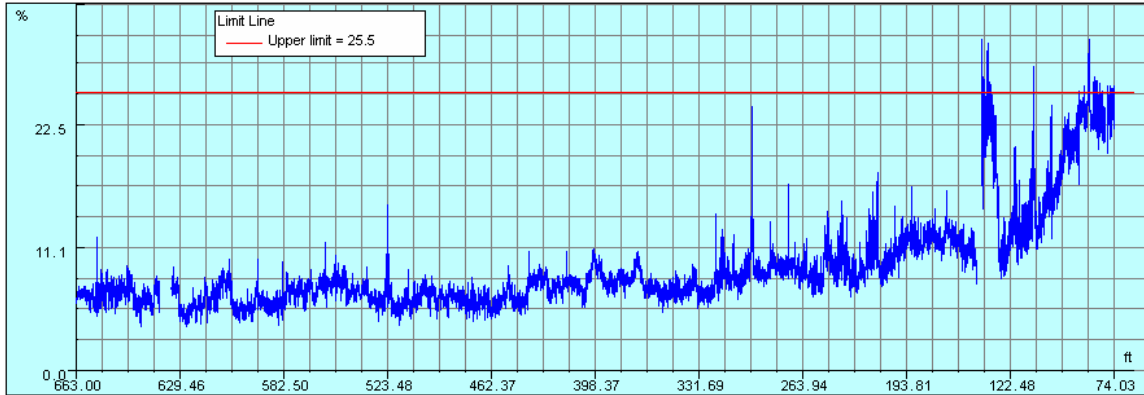
In this case the Ovality graph, a structural integrity indicator, compliments the Capacity graph. The graph in figure 5 shows a gradual increase in Ovality until the sharp increase, as expected, at the partial collapse section of the pipe. Also note worthy is the large amount of Ovality at and around 80ft.

Ovality(a)* as a percentage of original pipe versus time (frame number)
Figure 5: Ovality graph – as expect, severe Ovality at 141ft. Also large at and around 80ft.

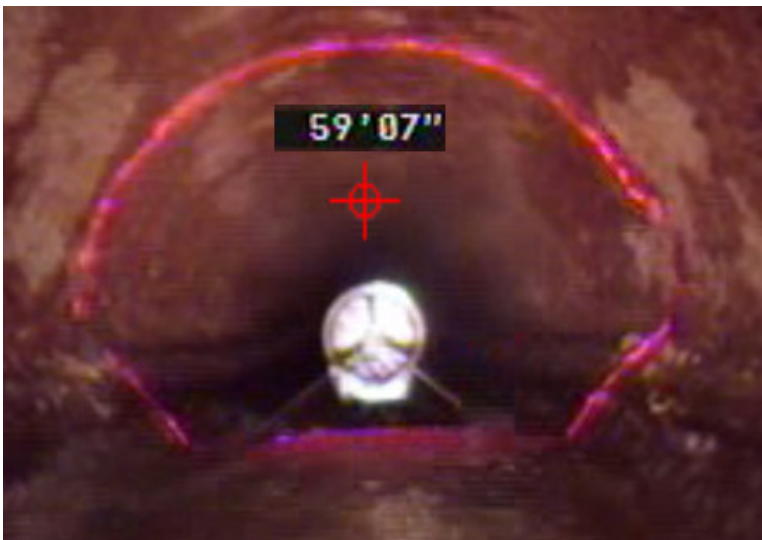
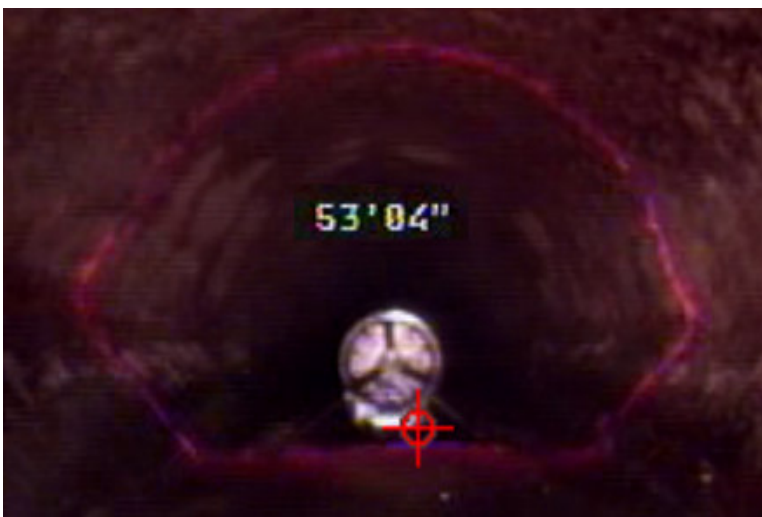
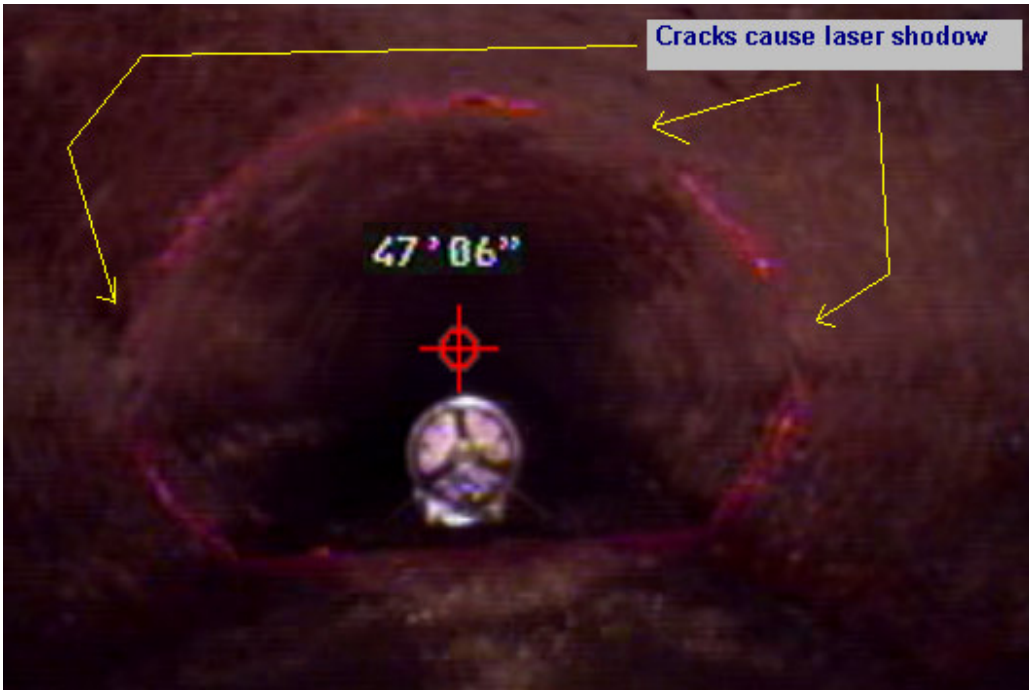
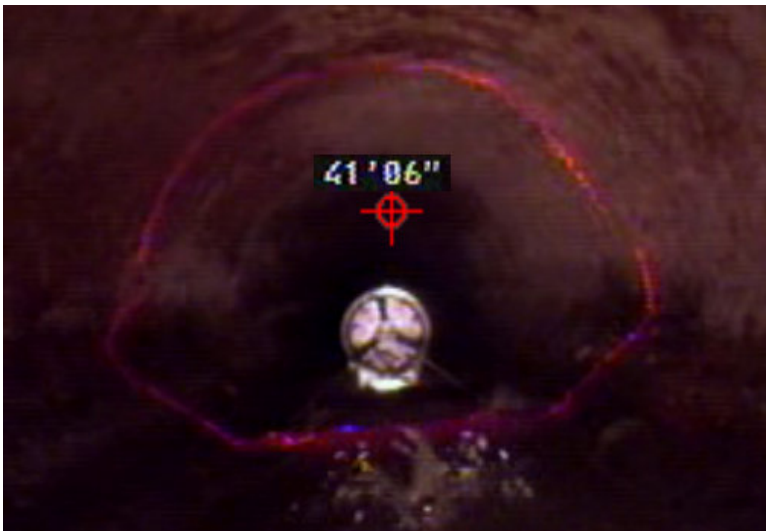
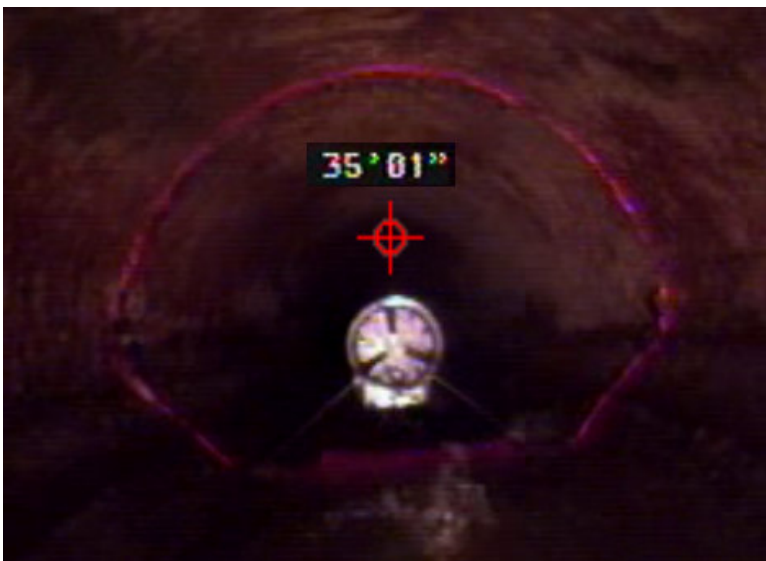
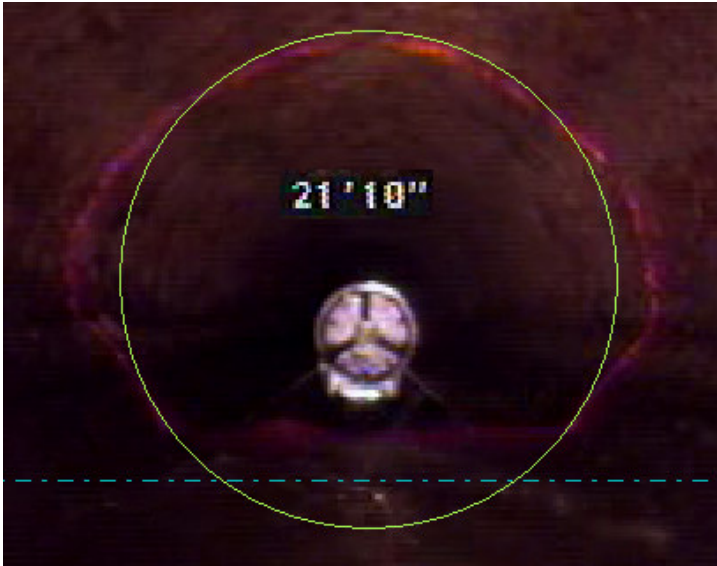
The remainder of the inspection had partial lights on, with the condition of the pipe, this made obtaining Precision Vision profiles very difficult. A higher resolution video file format would provide better results. The following are a selection of profiles collected over the remainder of the pipeline. Of particular interest, is the hole or lateral at 59ft and the cracking at 47ft.

Figure 6: A selection of profiles from 70ft to 0 ft.

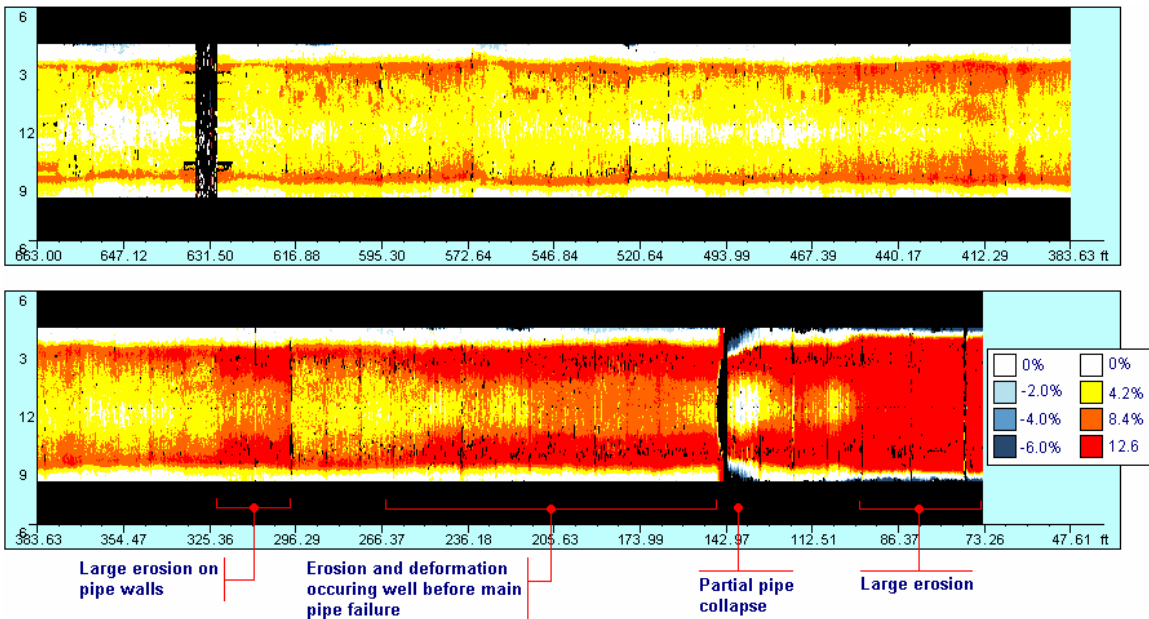
The Flat graph, the use of color to define depth or changes in dimension, correlates well with the Capacity and Ovality graphs.

Figure 7: The Flat graph highlights the changes in the erosion along the pipe walls.

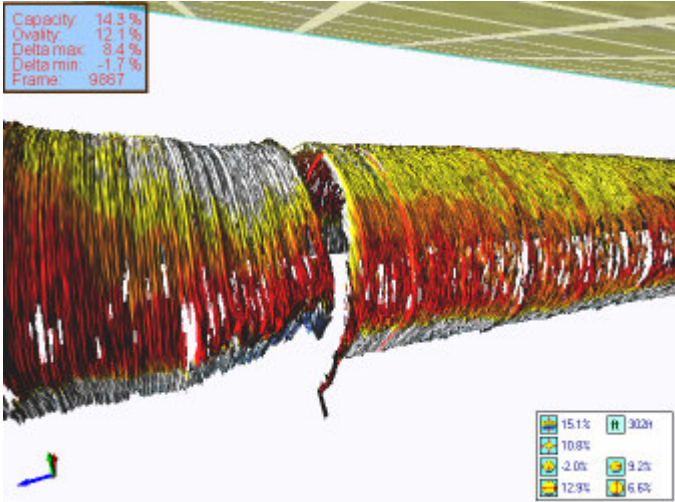
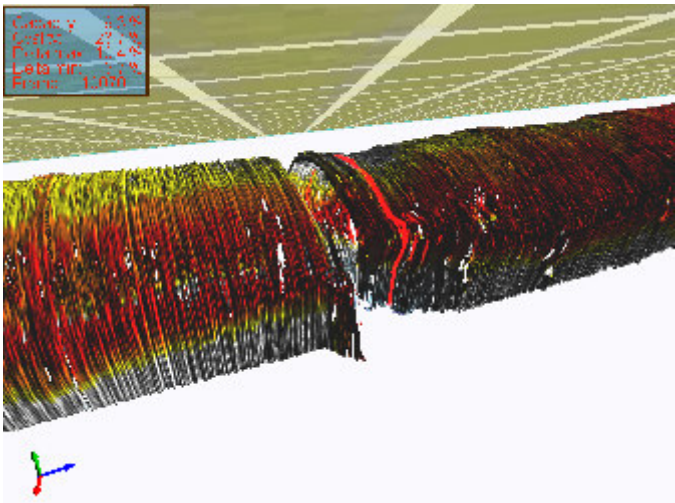
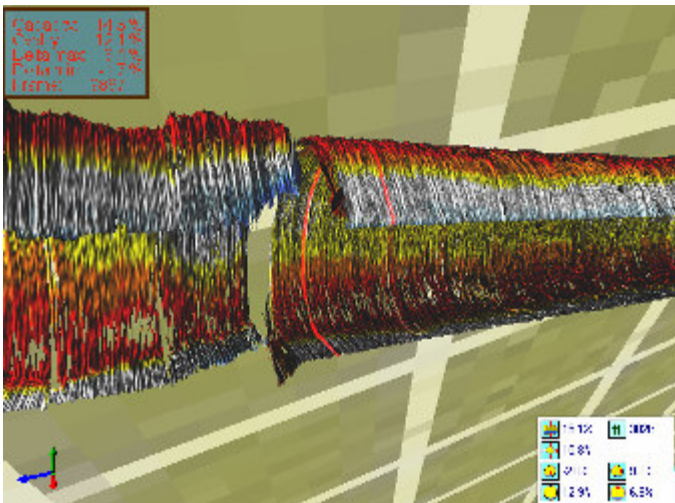
Figure 8: 3D of the area around the partial pipe collapse.
