# CLEARLINE PROFILER REPORT

**Location:** Chullora, Sydney Australia

**Pipe Size:** 1225

**Customer:** Sydney Water

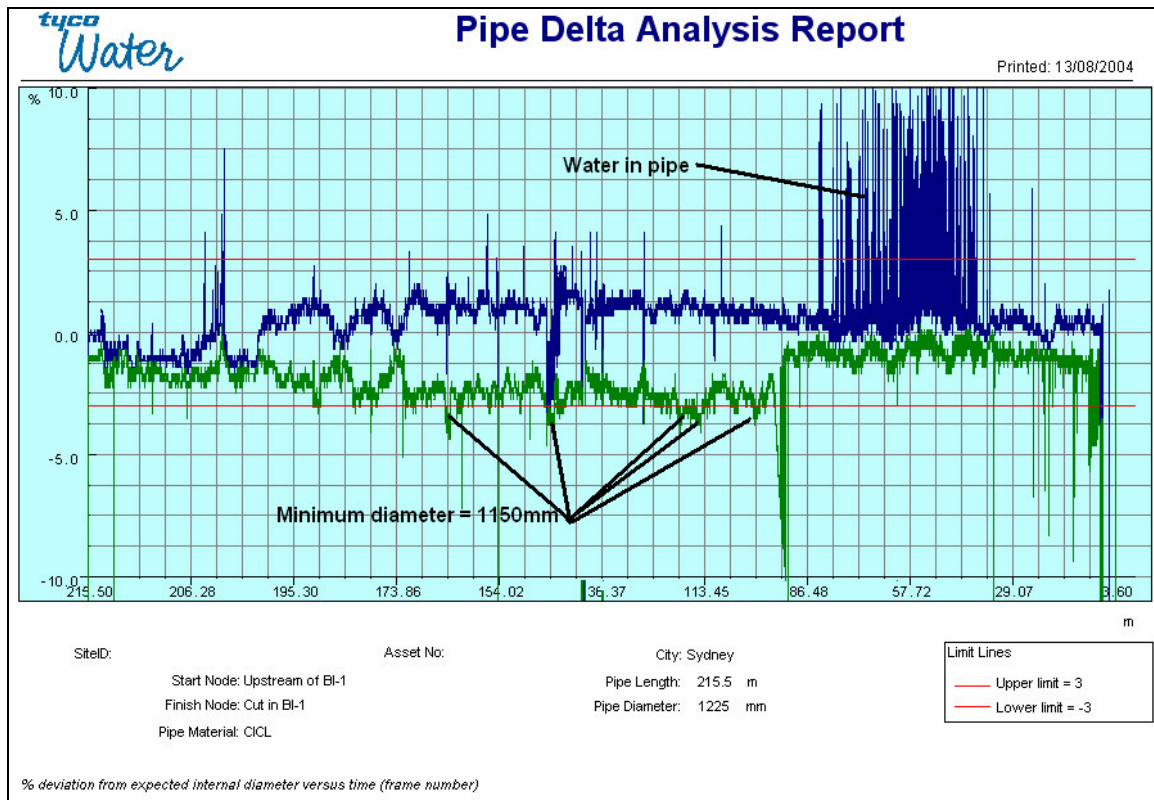
Delta

At various points within the pipe, the minimum diameter is 1150mm. These can be seen in the pipe delta report at points 163m (165.25), 140m (142.25), 123m (125.25), 120m (122.25) and 99m (101.25). Included in this report is an example profile at 120m.

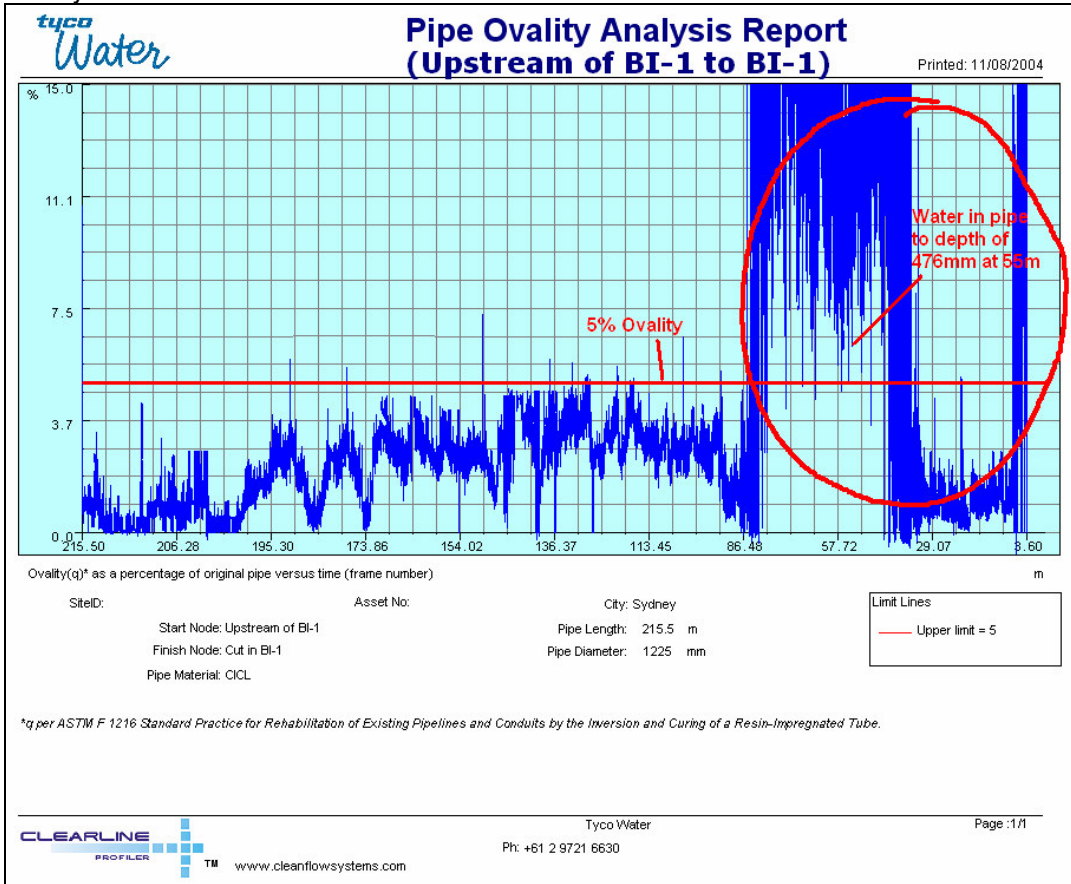
Ovality

Water levels are evident from the 95m point so no exact y diameters can be established, however the shape of the pipe visible do not indicate any serious deformation (past 1150mm).

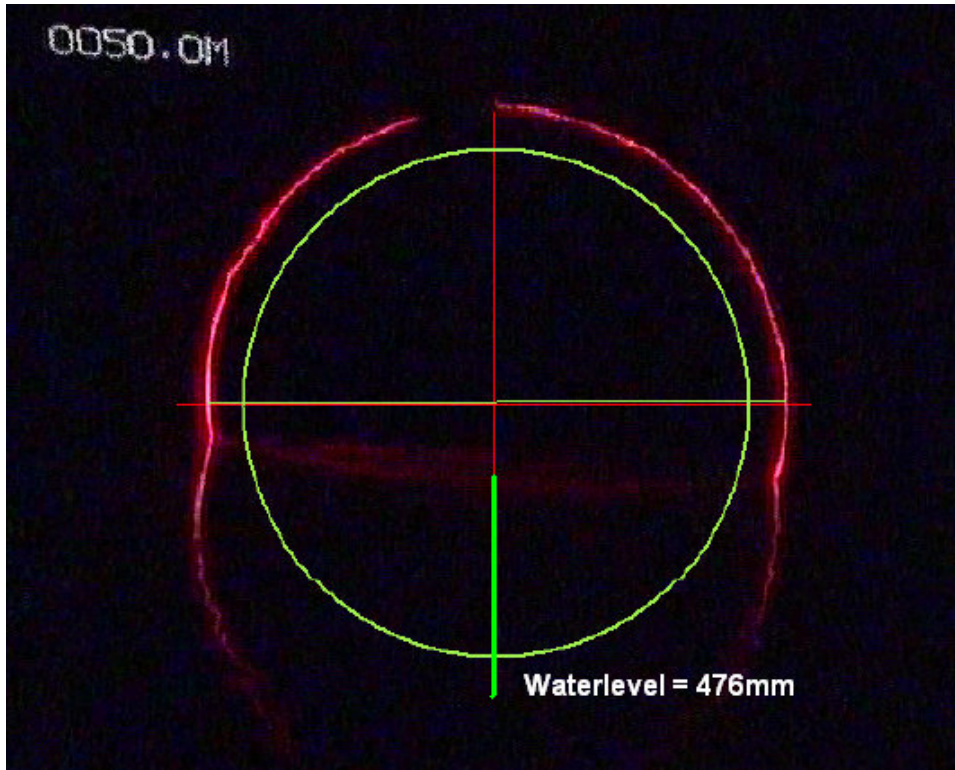
Waterlevel at 50m

Water is evident in the pipe from 95m (97.25) and increases to a maximum level of approximately 476mm at 50m upstream of BI-1. This then dissipates to almost no water by cut-in BI-1. This indicates a significant dip in the pipe.

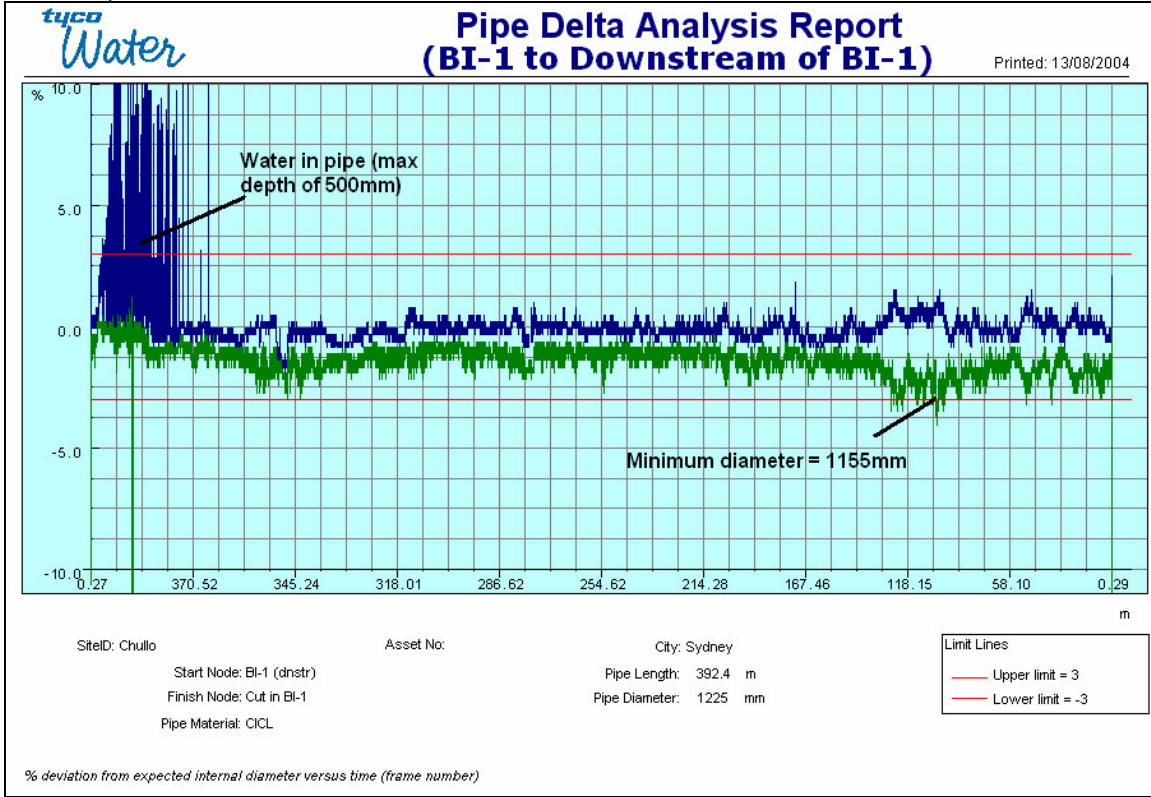
Delta Report

The minimum diameter for this pipe is 1155mm at 101m (103.25) downstream of BI-1.

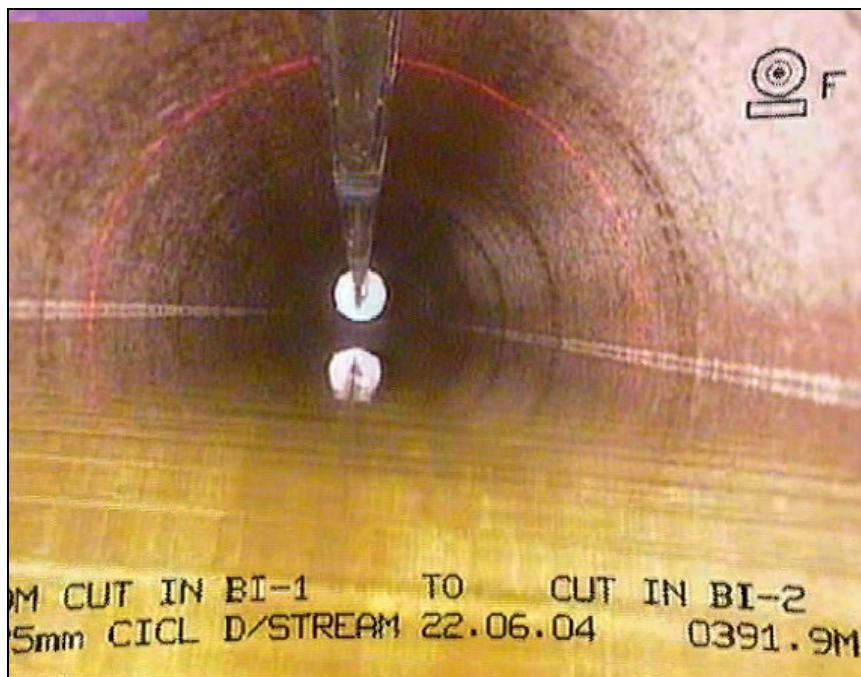
There is water in the pipe from 346m (348.25) and increases to a maximum level of approximately 500mm at 391m (393.25) downstream of BI-1. At this point, the high water level stops the profiling from continuing. This indicates a significant dip in the pipe.

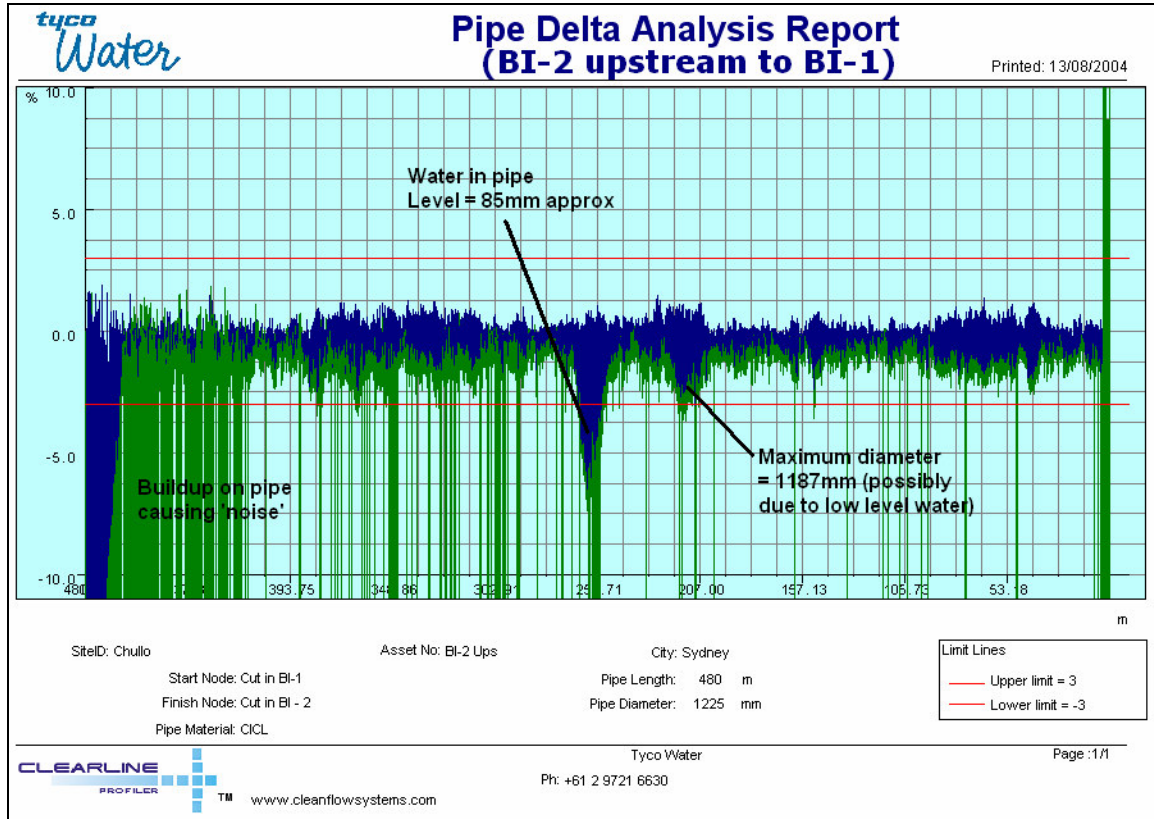
### Delta

Note: There is considerable fungal buildup on the walls of this (and the next section of) pipe. This caused the laser image to become fuzzy and dim. Tyco Water and CleanFlow Systems were able to record digital profiles, however they have some digital 'noise' due to this buildup. This 'noise' can be seen in the delta graphs as spikes (green) and should as such be ignored. The base trend of minimum radius can still be seen. It should also be noted that cross-sectional profiles for the entire pipe lengths have been analysed and are included for review as part of this extended report. For optimum results, we recommend all future profiling is performed post pipe cleaning.

This section of pipe is the least affected by deformation. The minimum diameter for this pipe is 1187mm at 236.6m (238.25) upstream of BI-2. This particular segment of pipe appears to include a small amount of water, so actual y diameter is more than likely similar to the other segments of pipe.

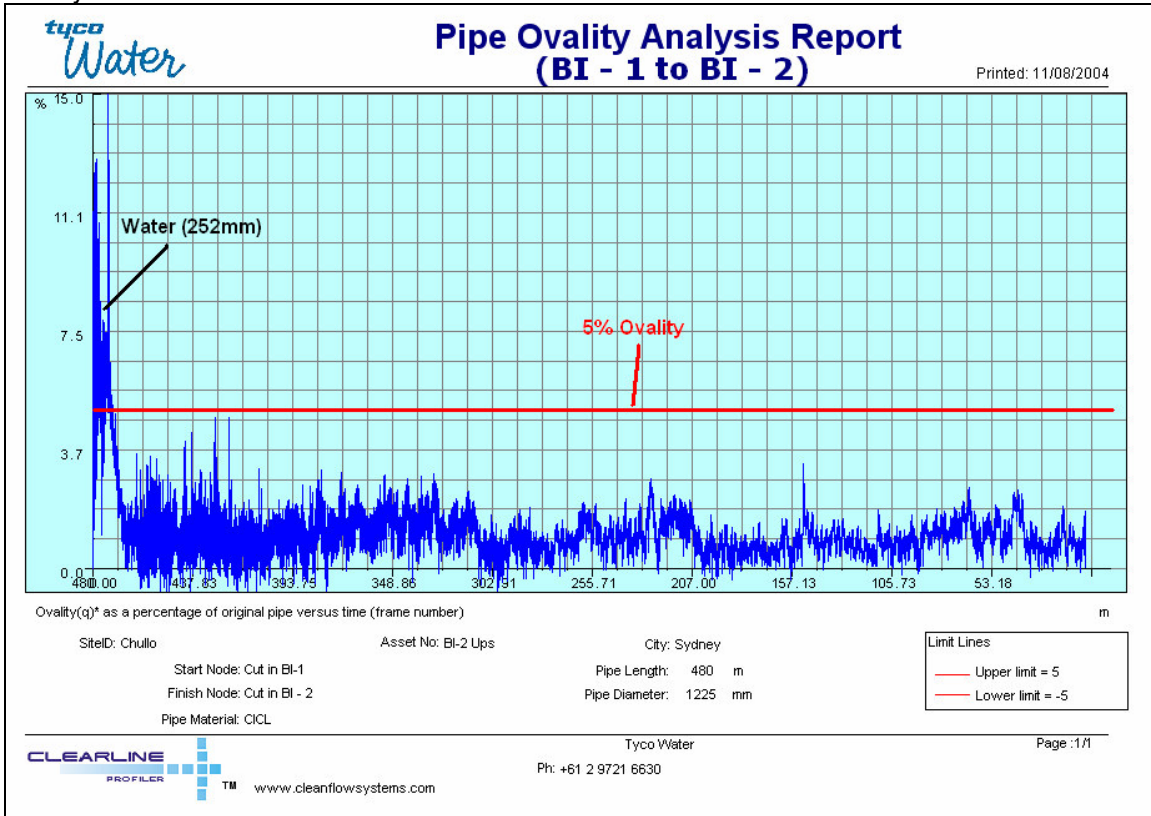
Ovality

There is a dip of 85mm (water level) in the pipe at 286m (288.25).

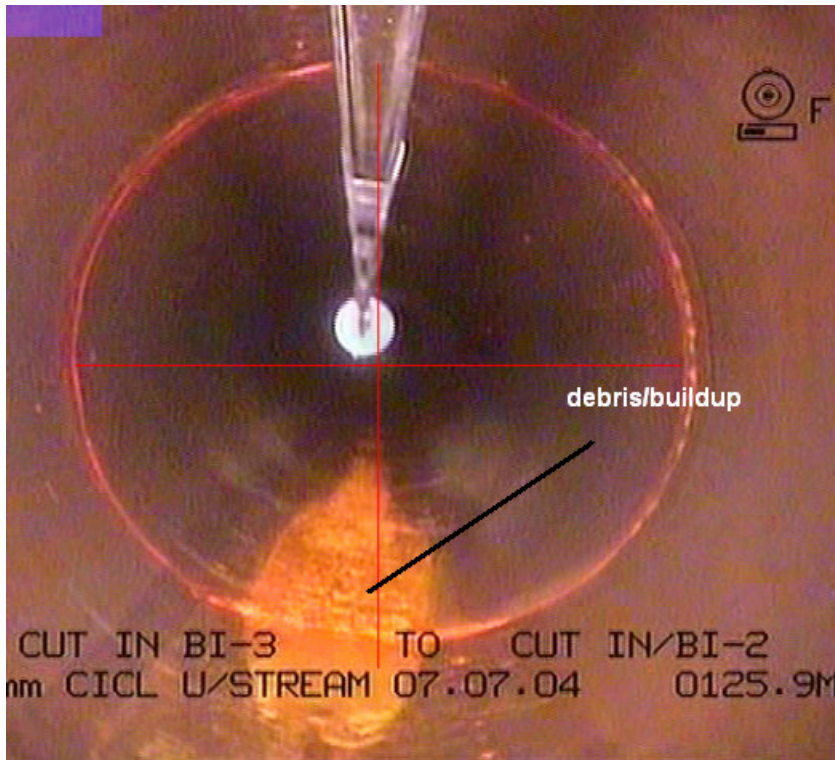
From 160m through to 110m, there is a noticeable pattern of deformation, the greatest deformation in this section of pipe. For the most part, this section remains above 1150mm, however between 154m to 141m, the diameter reduces to 1145mm.

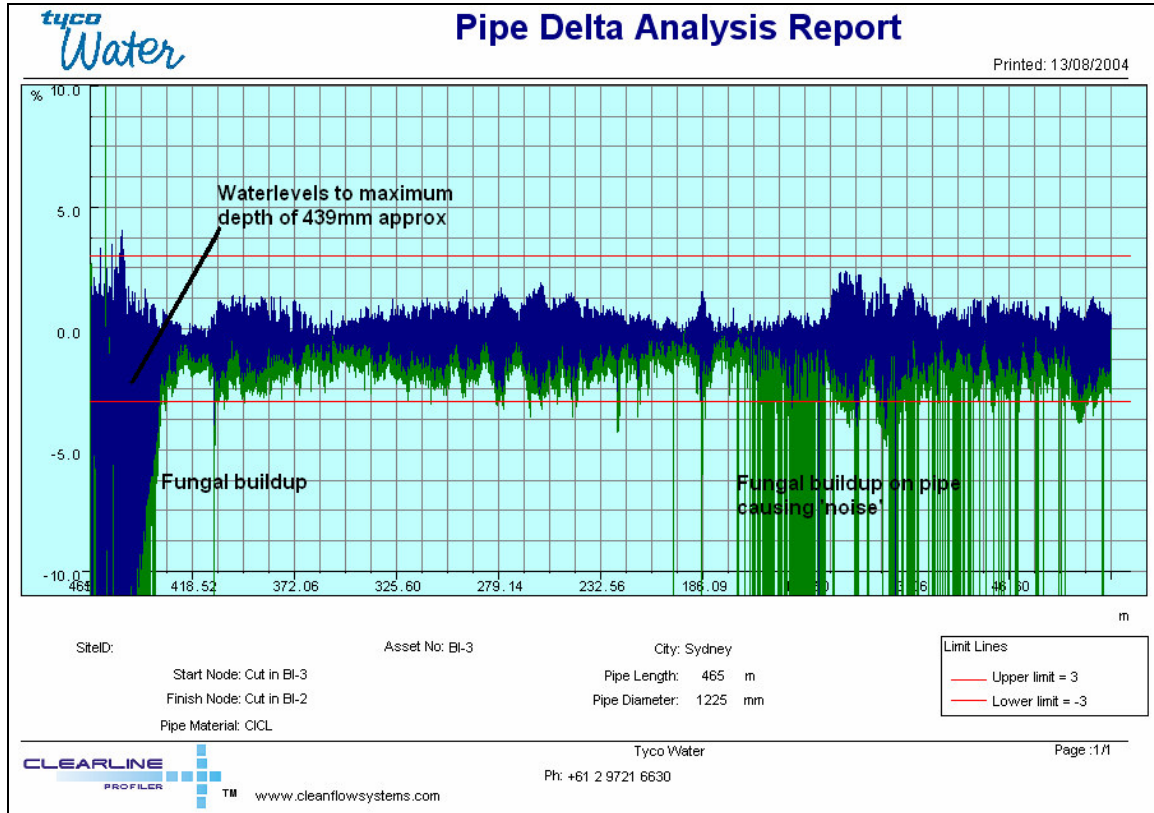
Delta

At 126m, there is some debris in the pipe, causing the diameter to reduce to 1115mm. However, the diameter increases to a more realistic minimum of 1131mm at 129m (131.25) from BI-3.

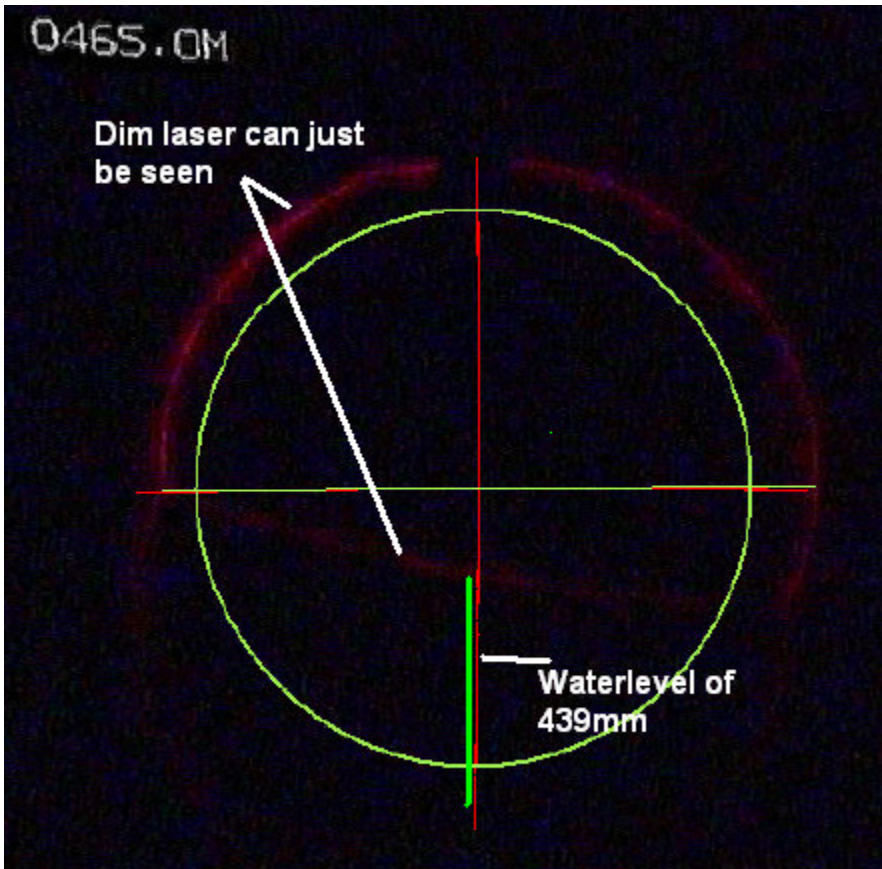
Water becomes visible in the pipe from 444m (446.25) and increases to a level of 439mm at 465m (467.25) upstream of BI-3. This indicates a dip in the pipe. The camera stopped at this point.

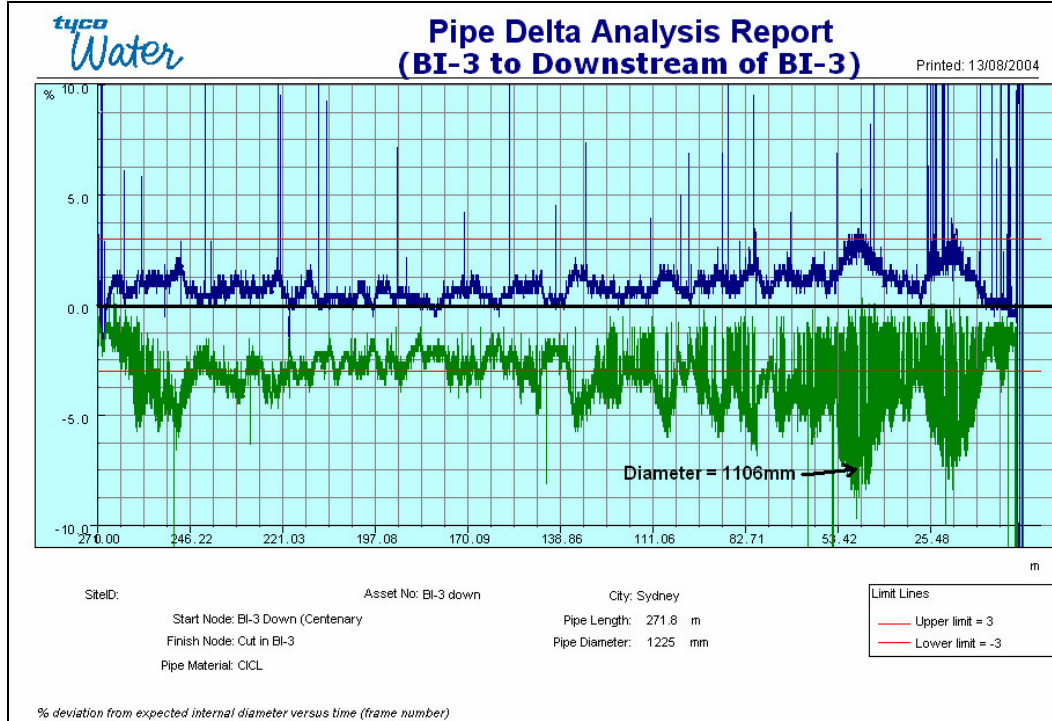
### Delta

This pipe is the most affected by pipe compression. The pipe has a minimum pipe diameter of 1106mm at 46.8m (49.05m true) from BI-3. This deformed section between 43m (45.25) and 53m (55.25) can be seen in the pipe delta and ovality reports.

Similar levels of compression are evident from 23m (25.25m) through to 16m (18.25m).
