# CLEARLINE PROFILER CASE STUDY

## CIPP RELINING FAILURE

**Location:** Portland, Oregon, USA

**Customer:** City of Portland

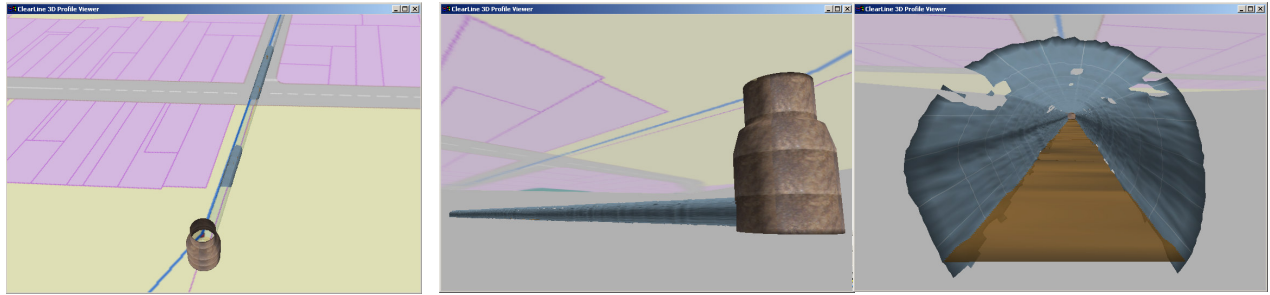
*Figure 5: 3-Dimensional representation of digital pipe profile*

Along the length of the 24" section of pipe surveyed, the maximum lift measured was 1.9" (48mm) or 8.4%.

3D graphical representation of the pipeline helps to better visualize the defects in the pipeline. In this case, the addition of environmental factors, including roads, buildings and vegetation, were added to provide an enhanced dimension to the inspection.
