# CLEARLINE PROFILER REPORT

**Location:** Chullora, Sydney Australia

**Pipe Size:** 1225

**Customer:** Sydney Water

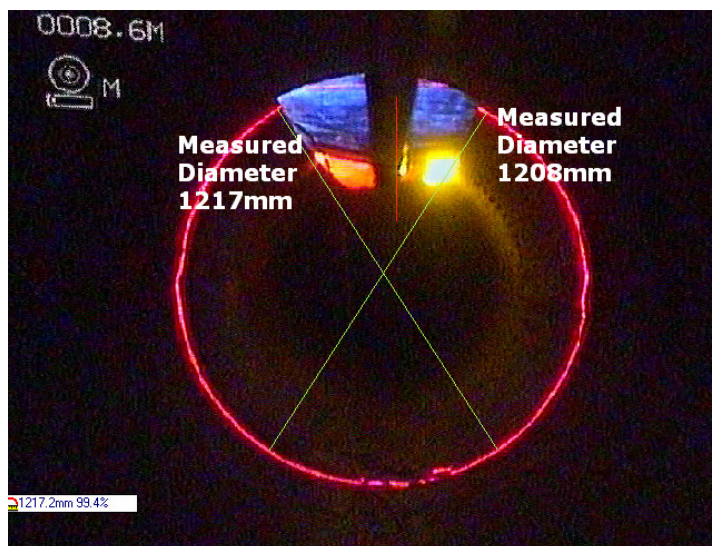
1. CleanFlow Systems measured the pipe diameter on either side of the cut in at BI-1. Measurement = 1208mm. Measurement B = 1217mm. These same diameters can be seen below (with laser ring).
2. 1000mm calibrator placed on the end of laserhead.

Both forms of calibration reconciled.

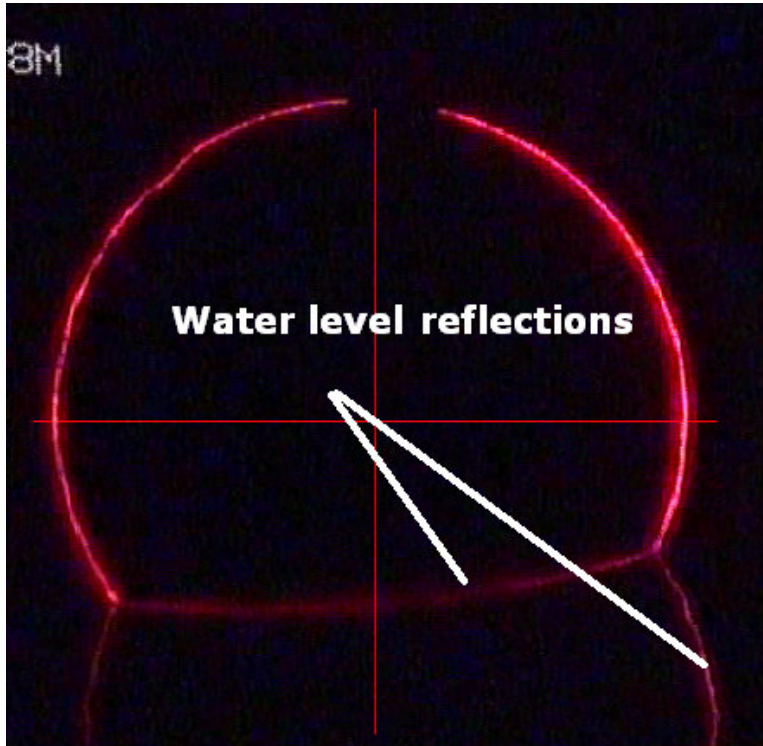
At various points within the pipe, water levels became too high for profiling. No analysis can be performed below the water-level (or below debris). Optimum results are achieved with no water. Where water is detected, estimates based on the expected diameter and the shape of the visible pipe is used to predict diameter.
